Corrective Measures Completion Report for the Corrective Measures Implementation at Solid Waste Management Unit 11, Laundry Effluent Pond and Waste Pile Areas

**Tooele Army Depot
Tooele, Utah**

Prepared for:
Sacramento District
U.S. Army Corps of Engineers
Sacramento, California
By North Wind, Inc.
Contract No. DACW05-00-D-0024, D.O. 006

May 2004

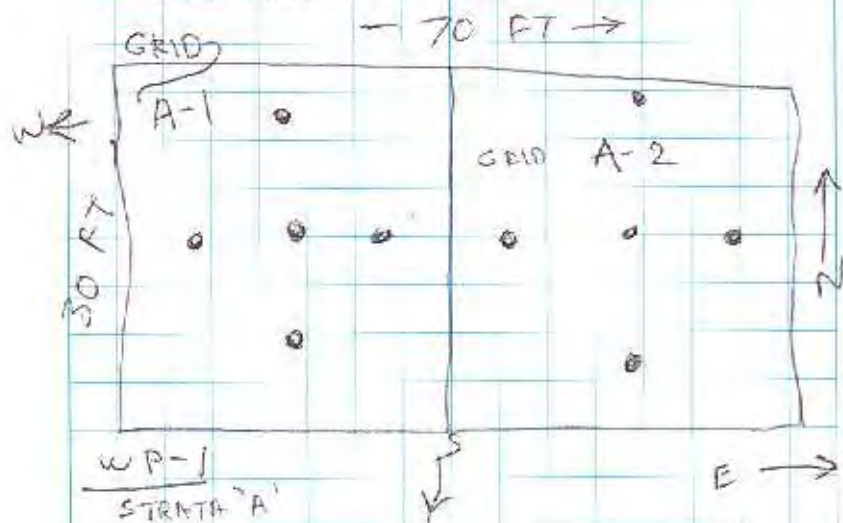
DIVIDED WP-1 INTO TWO 30 X 35 FT
BLOCKS FOR STRATA A.

STRATA B WILL BE SAMPLED AS ONE
30 X 70 FT BLOCK AT 2.5 FT DEPTH

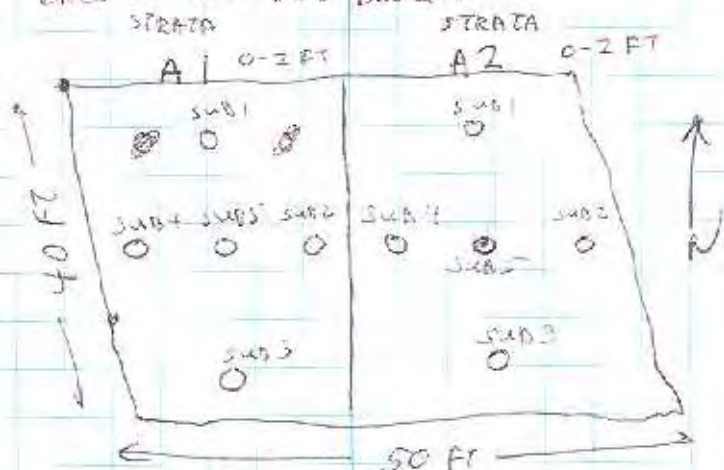
WASTE PILE # 2

DIVIDED WASTE PILE E2 INTO 2 25X20 FT
BLOCKS AND COLLECTED A COMPOSITE SAMPLE FROM
EACH OF THE TWO BLOCKS

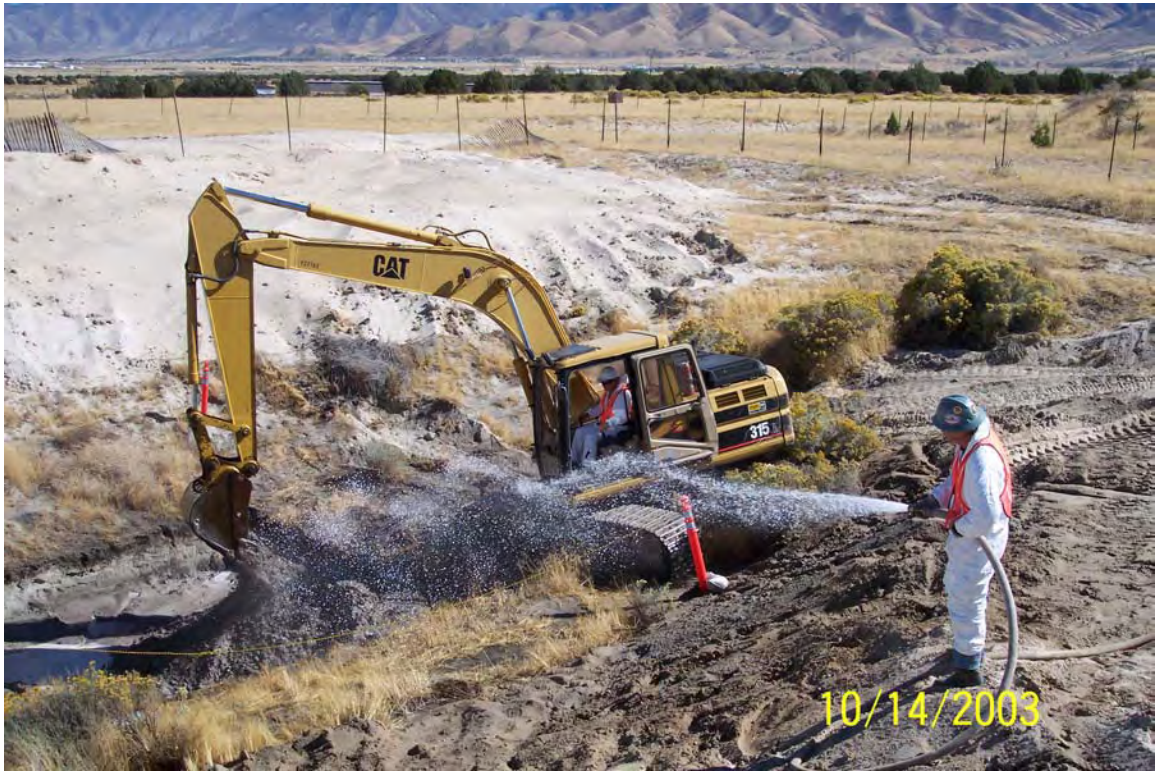
Figure C-1. Dust control at the laundry effluent pond excavation.

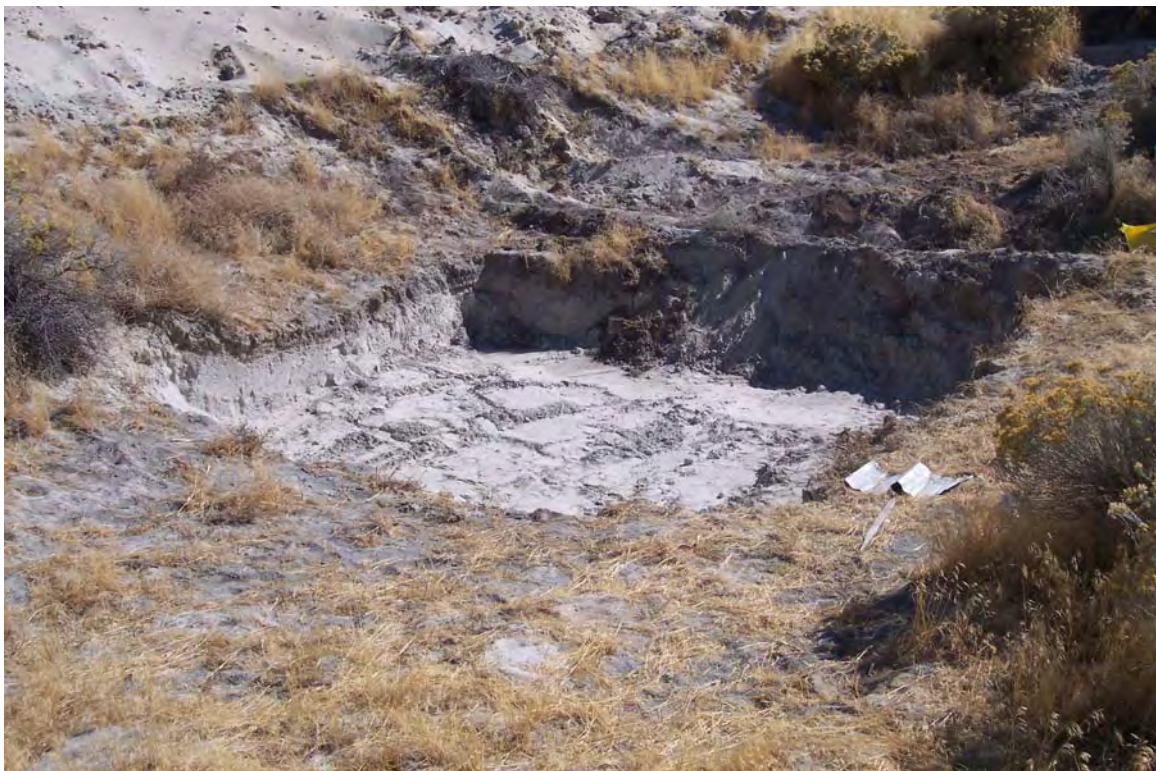
Figure C-2. Completed laundry effluent pond excavation.

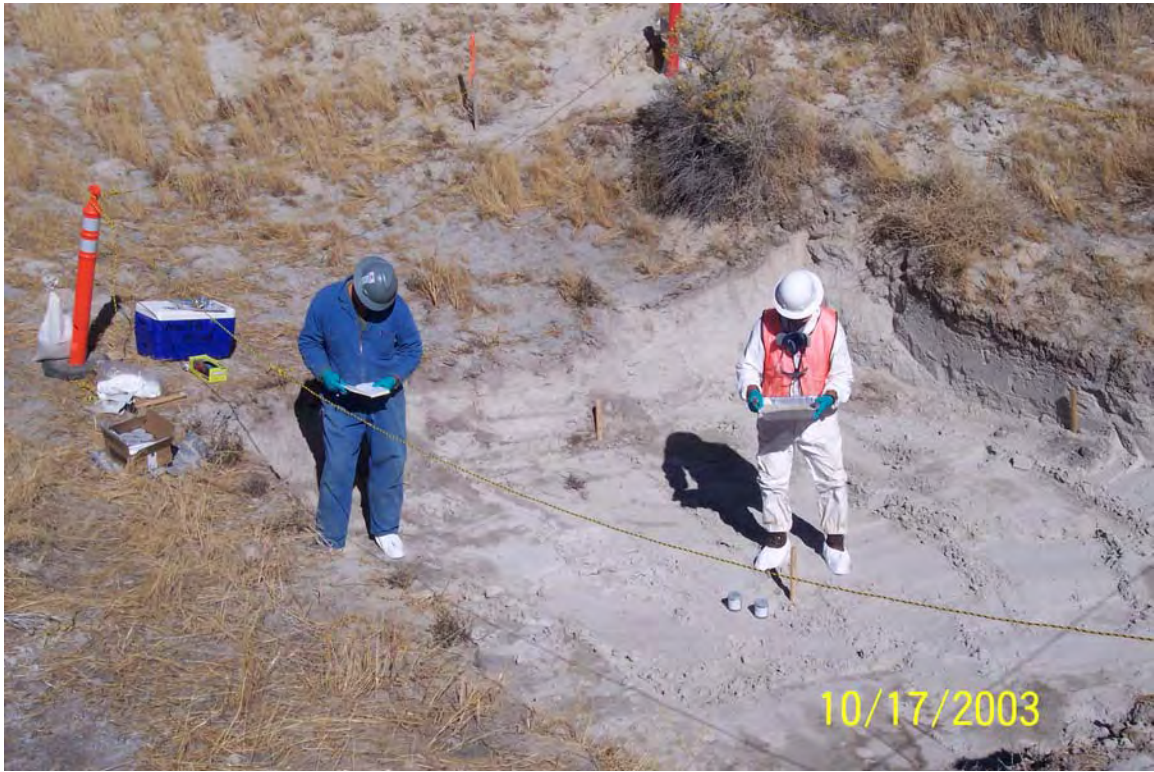
Figure C-3. Sampling at the laundry effluent pond.

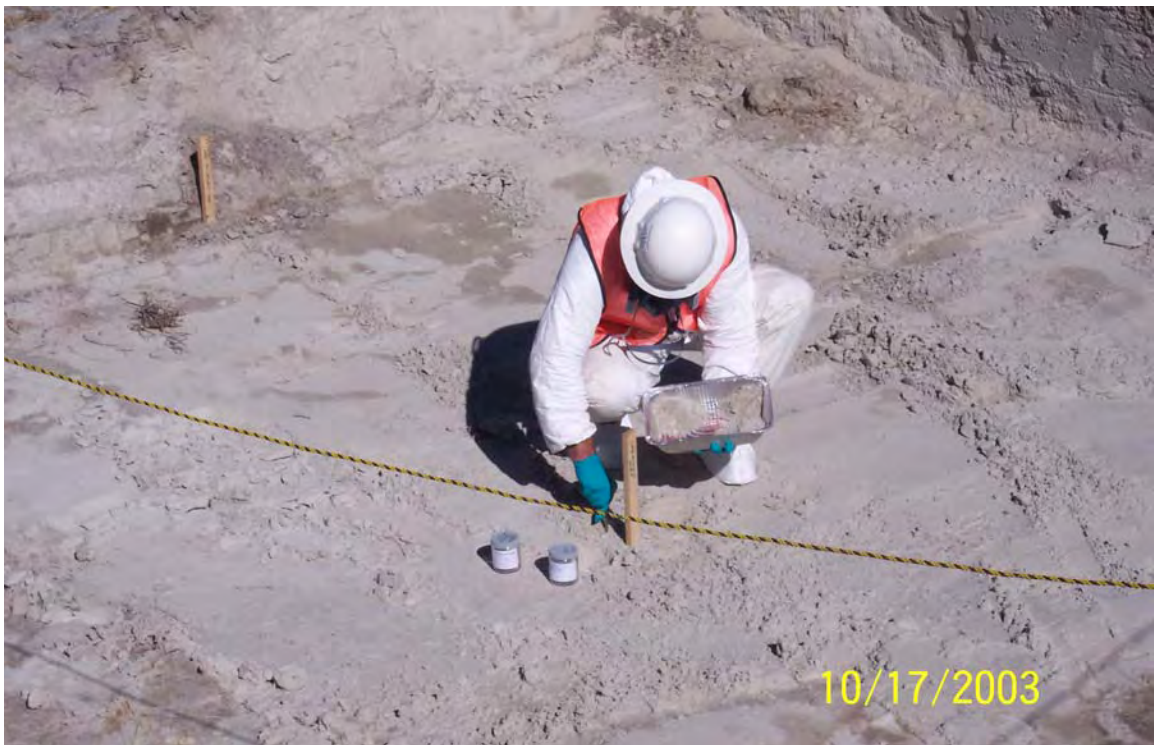
Figure C-4. Close view of compositing procedure for split samples at laundry effluent pond.

Split samples were collected by placing approximately 30 mL of soil into a disposable aluminum pan, homogenizing the sample by hand using a stainless steel spoon, and then filling each sample jar with a few grams at a time from the homogenized batch of soil. An equipment blank was also collected by rinsing all of the decontaminated sample spoons and the aluminum mixing pan with high purity water and collecting the rinsate in a 500-ml HDPE container.

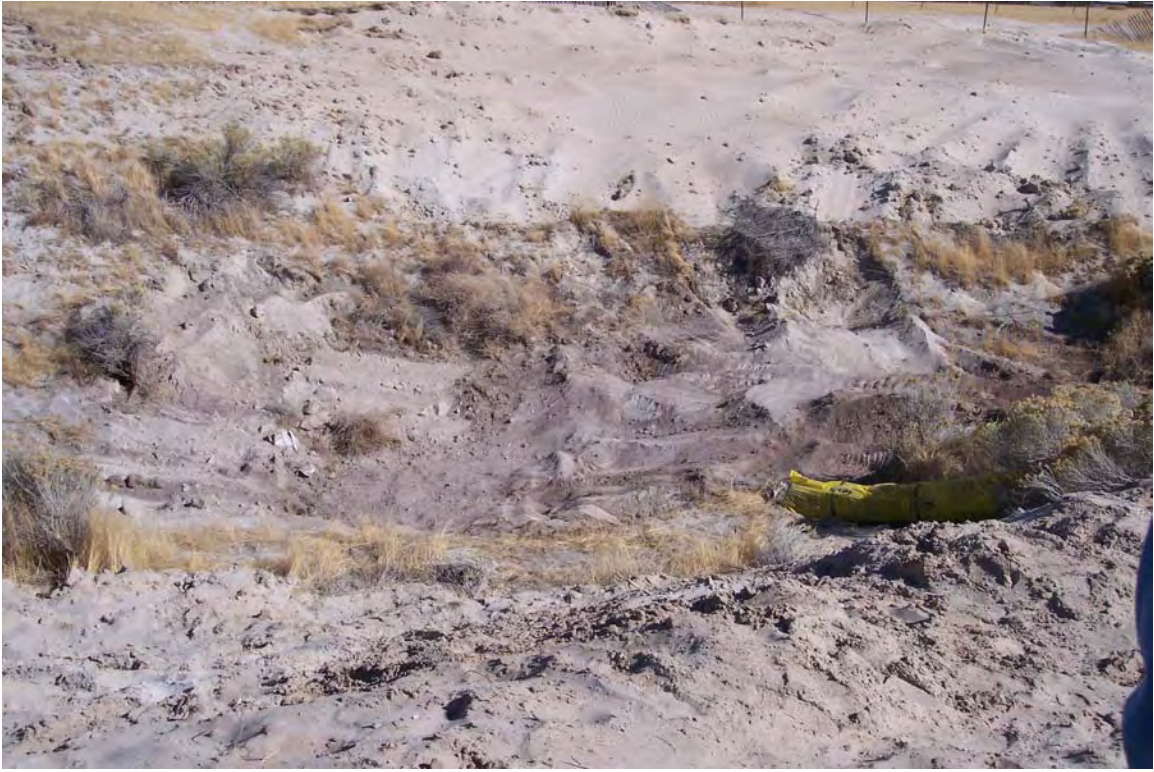
Figure C-5. Contoured laundry effluent pond prior to biomat installation.

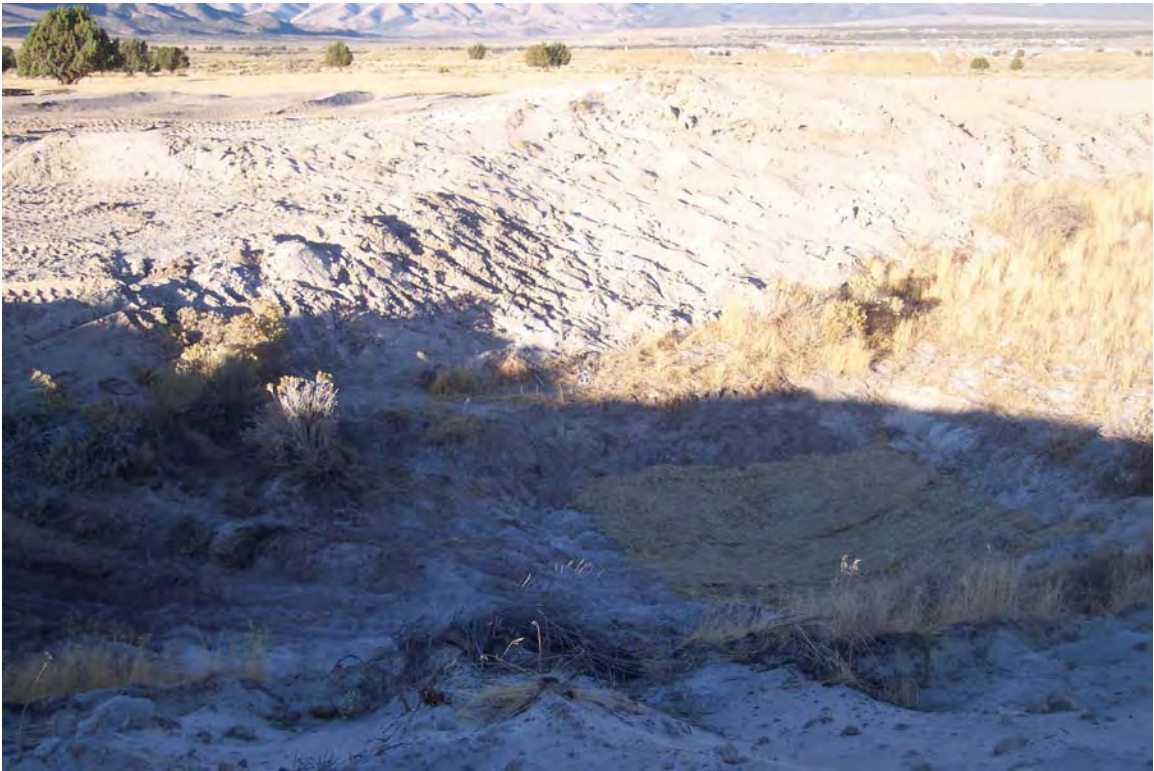
Figure C-6. Laundry effluent pond with biomat installed.

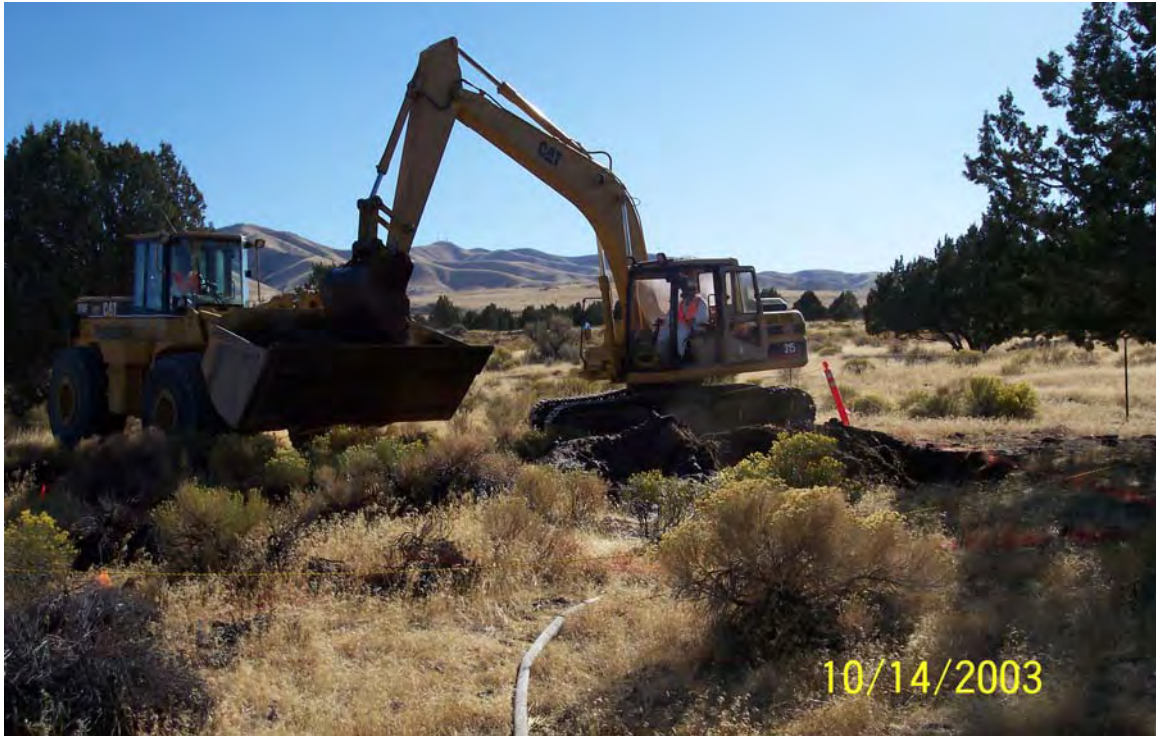
Figure C-7. Start of Waste Pile 3 excavation.

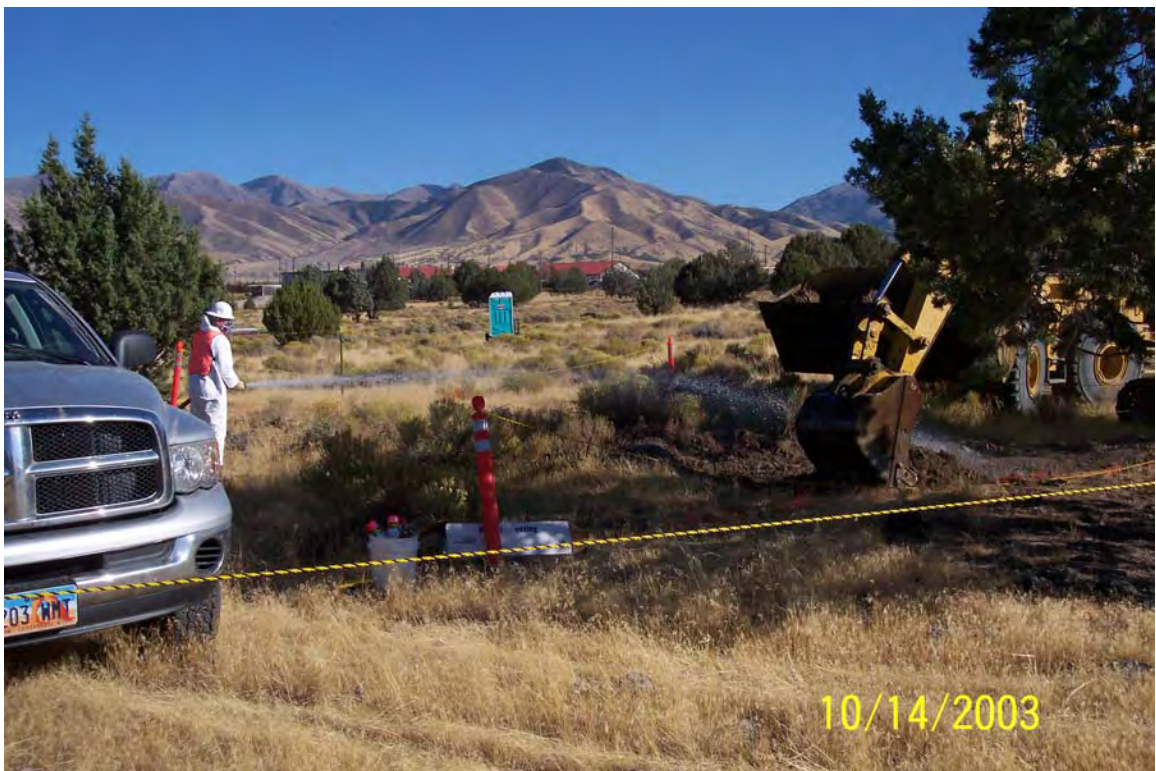
Figure C-8. Dust control at the Waste Pile 3 excavation.

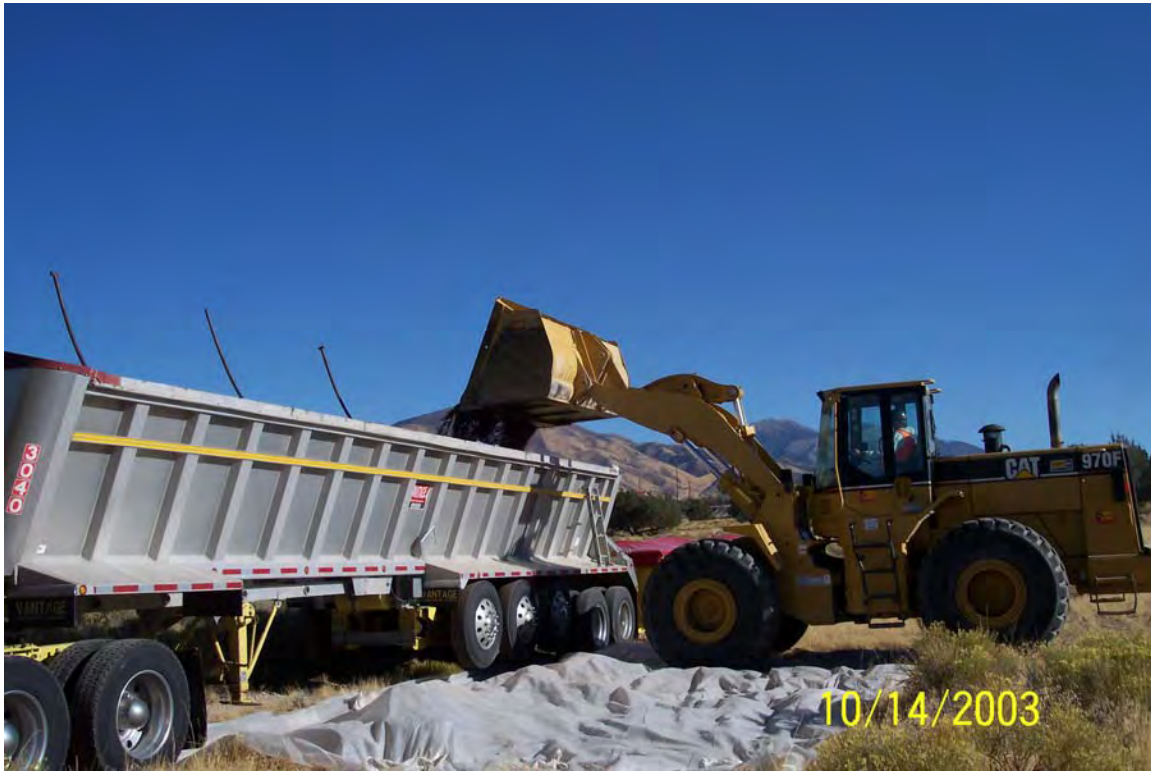
Figure C-9. Loading an end dump truck.

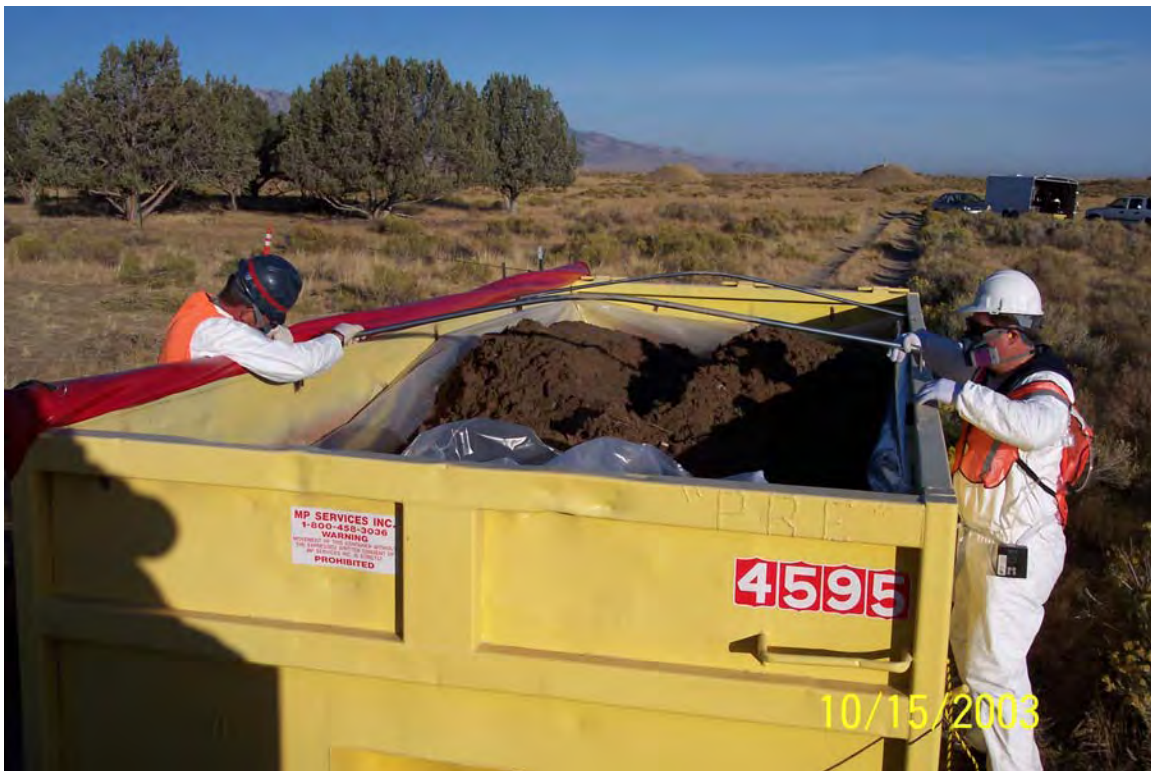
Figure C-10. Preparing to close a roll-off bin filled with Waste Pile 3 soil.

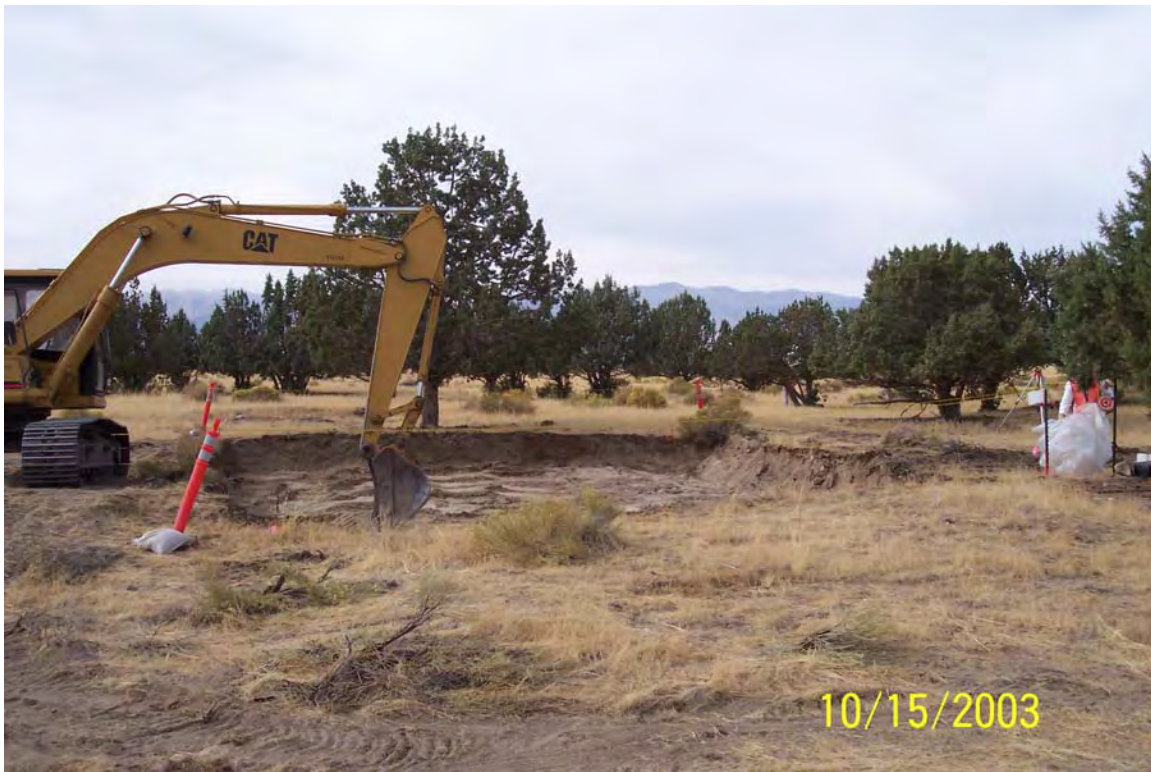
Figure C-11. Completed Waste Pile 3 excavation.

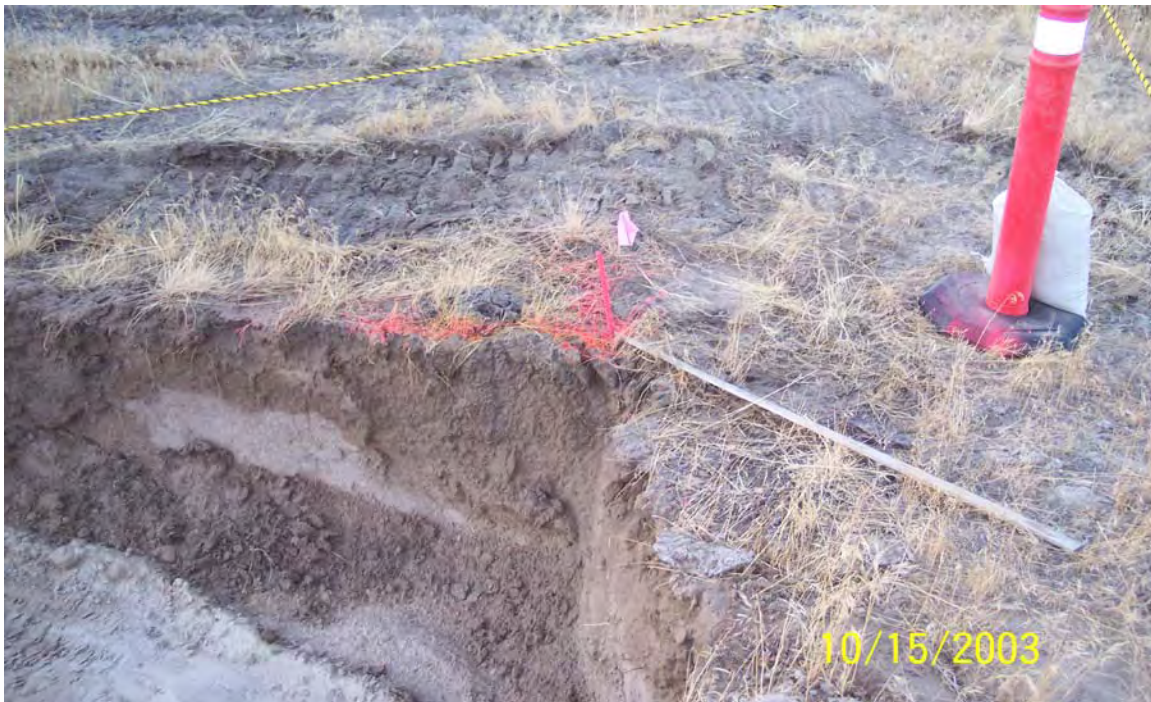
Figure C-13. Excavation locations were based on USACE rebar stakes (NW corner Waste Pile 3 shown here).

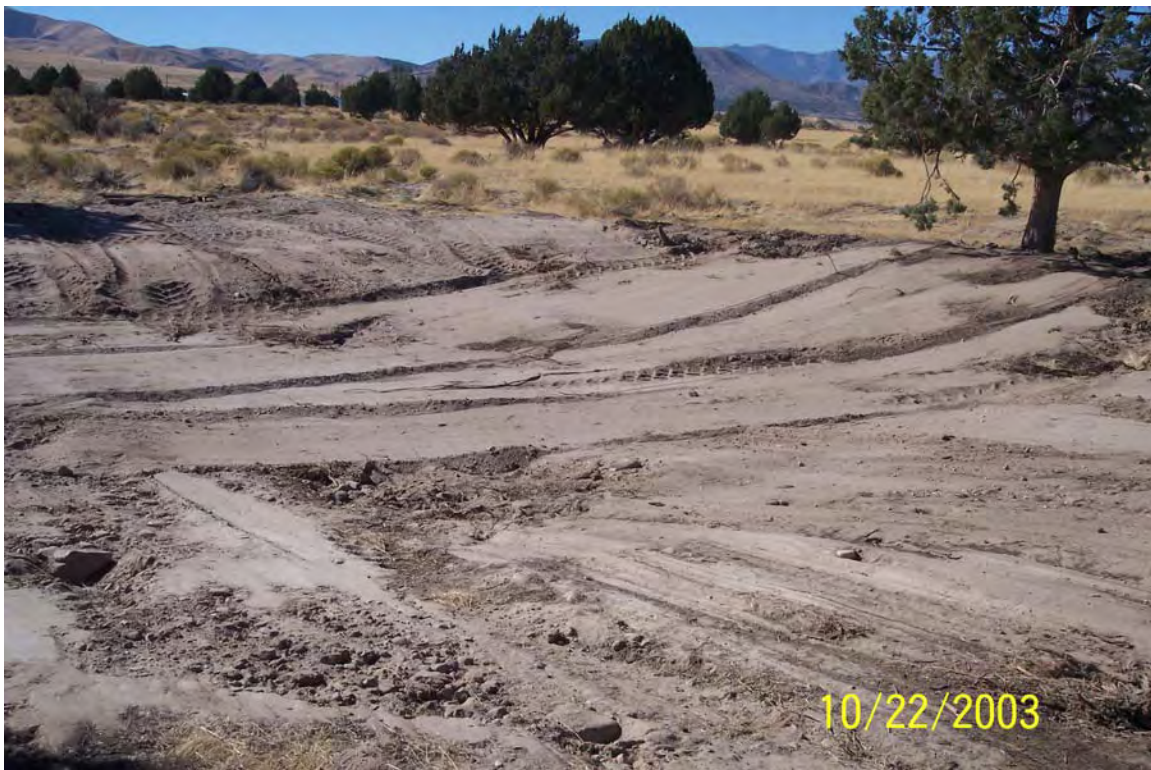
Figure C-14. Contoured Waste Pile 3.

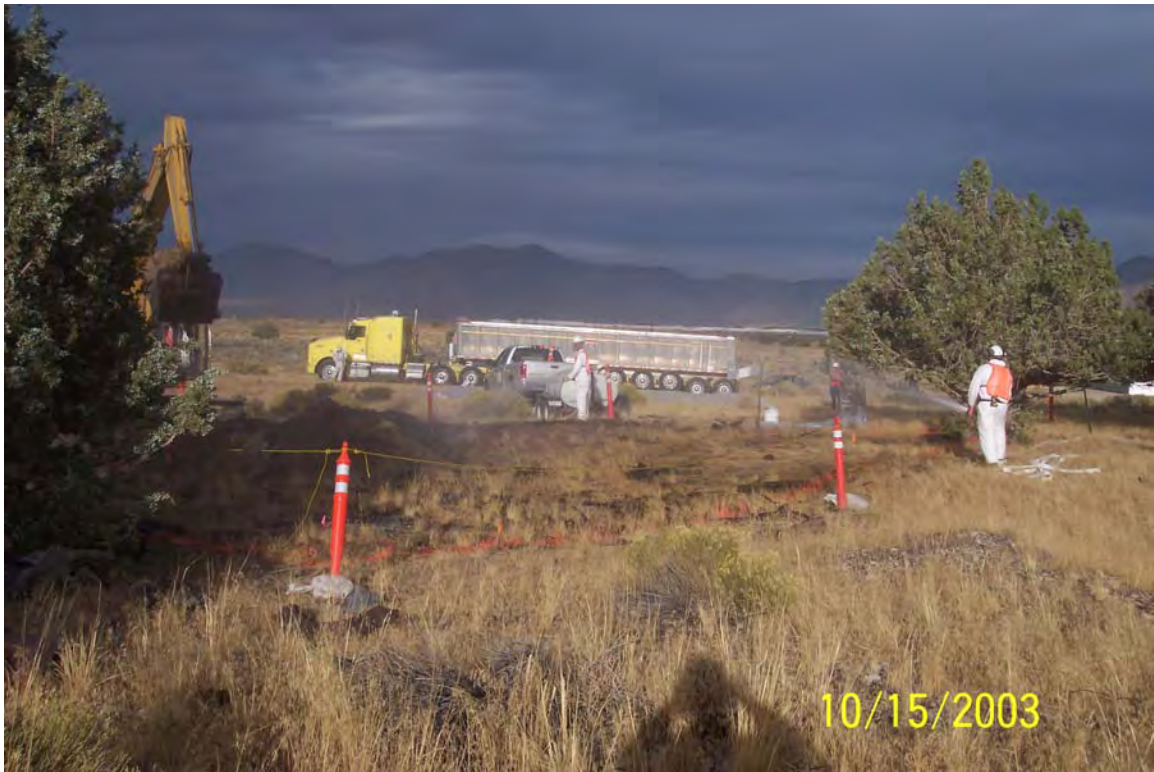
Figure C-15. Start of Waste Pile 2 excavation and dual hose dust control.

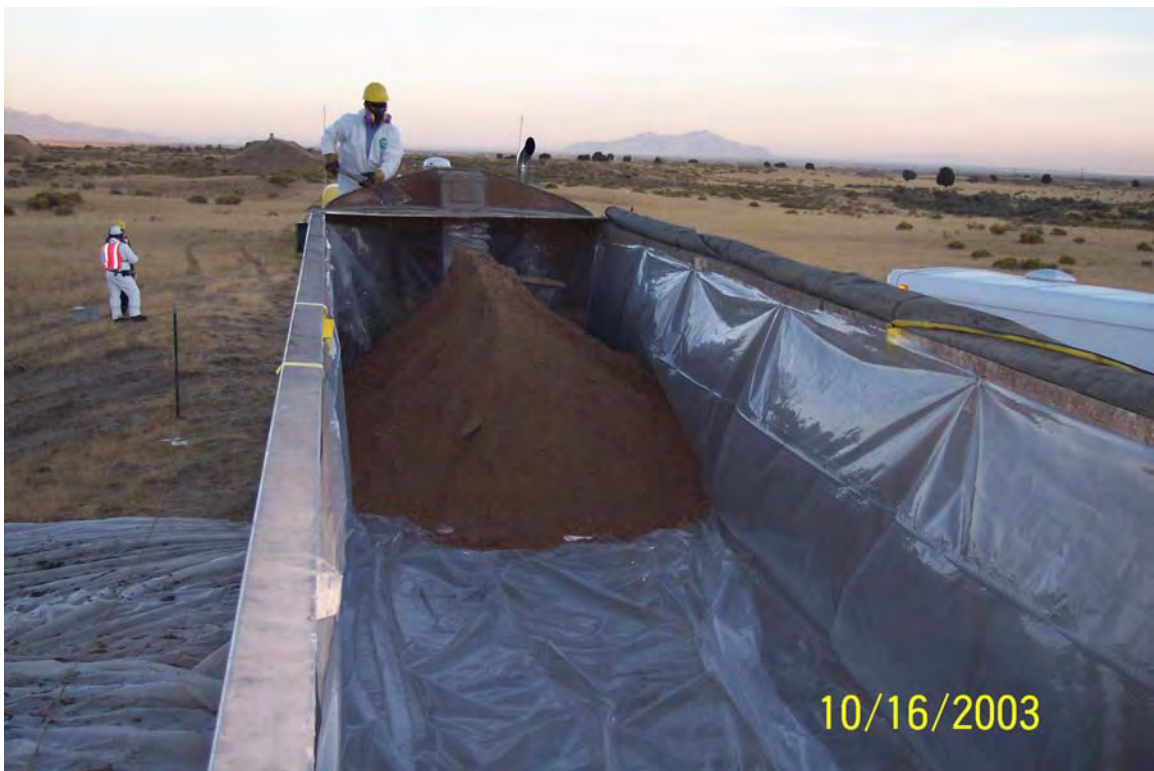
Figure C-16. Partially loaded truck with Waste Pile 2 soil.

- Waste Pile 2 was excavated on October 15 and 16, 2003. An area measuring 50 × 42 ft was excavated to a depth of 2 ft bgs (approximately 156 yd³ of soil). Waste Pile 2 soils contained some small debris including wood fragments, scrap metal, concrete, and broken glass. A total of eight end dump trucks and two 20-yd³ roll-off bins were filled.

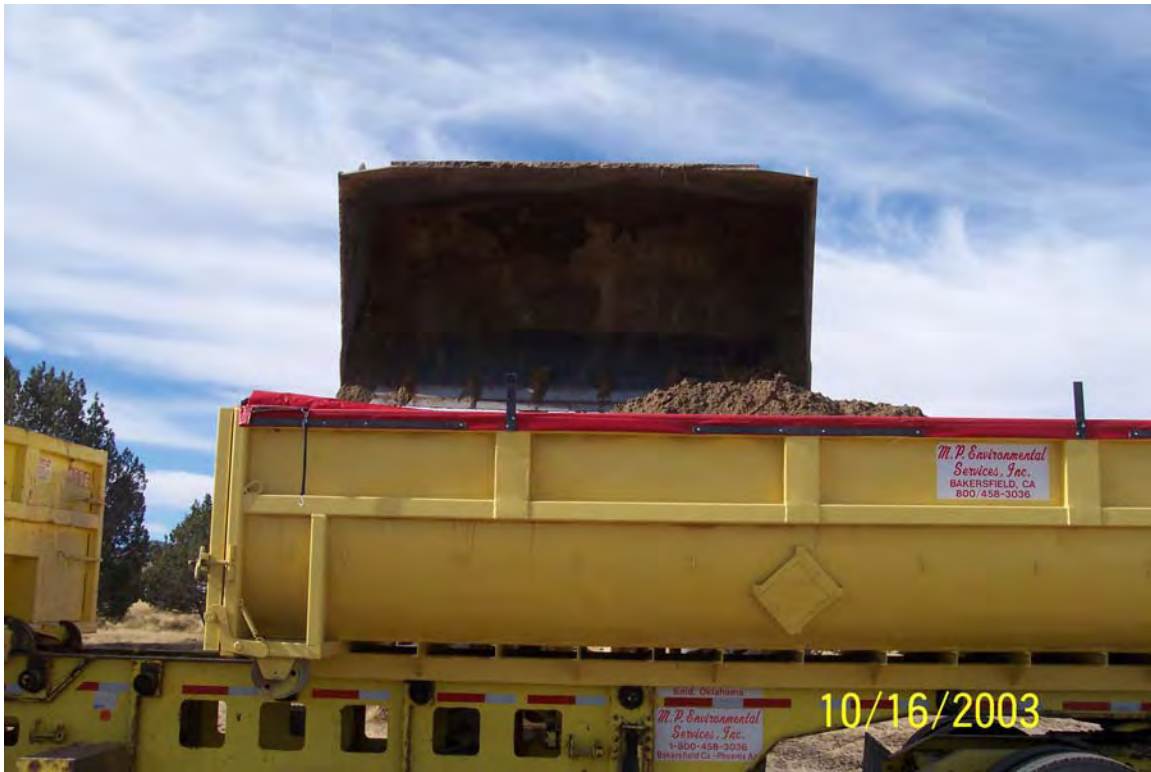
Figure C-17. Loading a roll-off bin still on the truck with Waste Pile 2 soil.

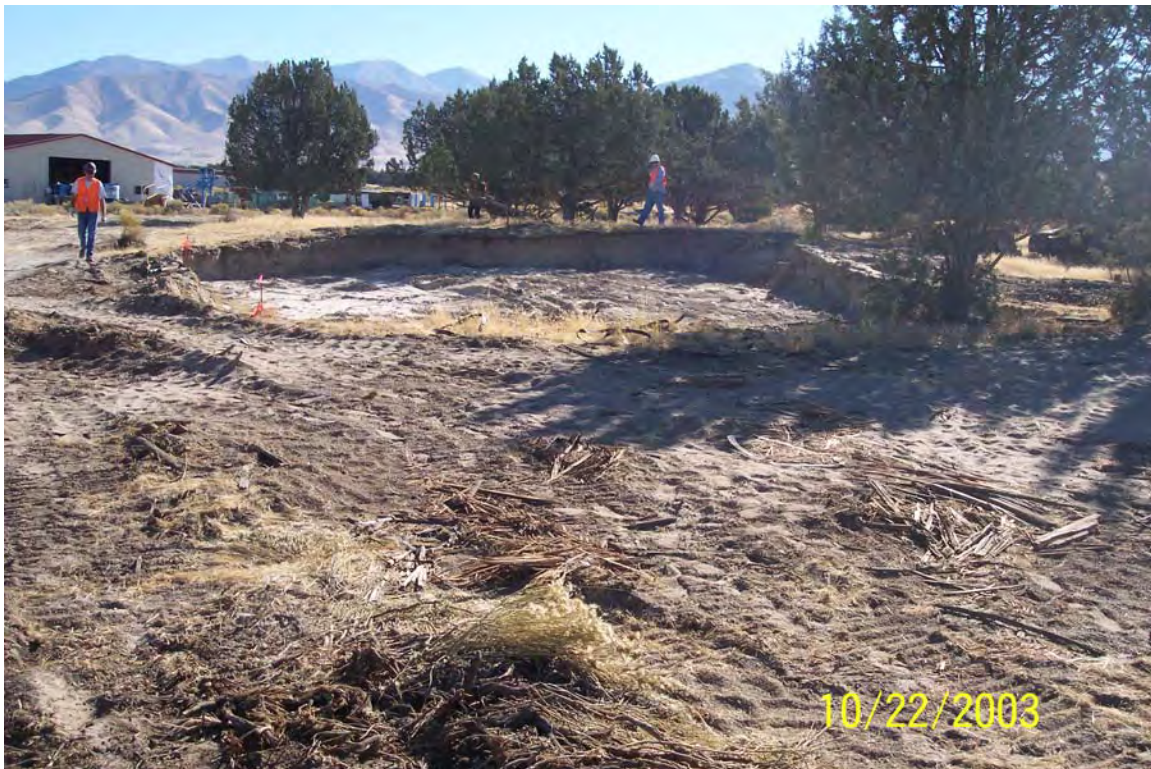
Figure C-18. Completed Waste Pile 2 excavation.

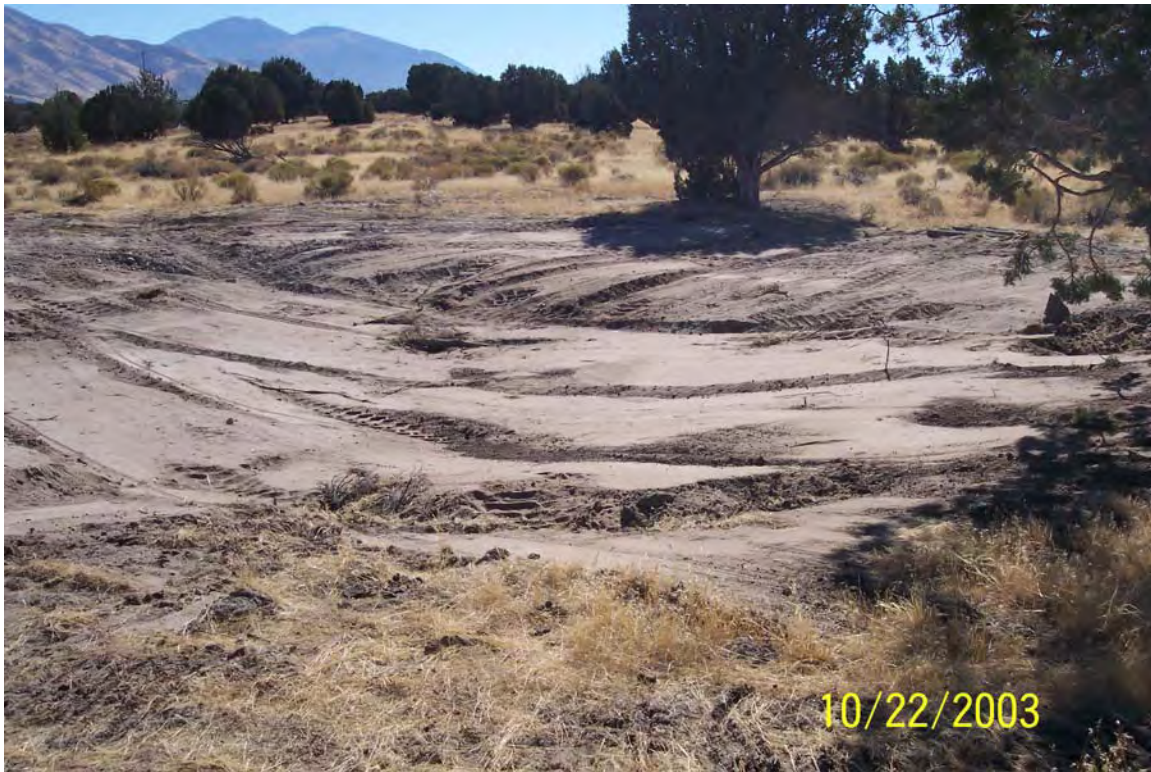
Figure C-19. Contoured Waste Pile 2.

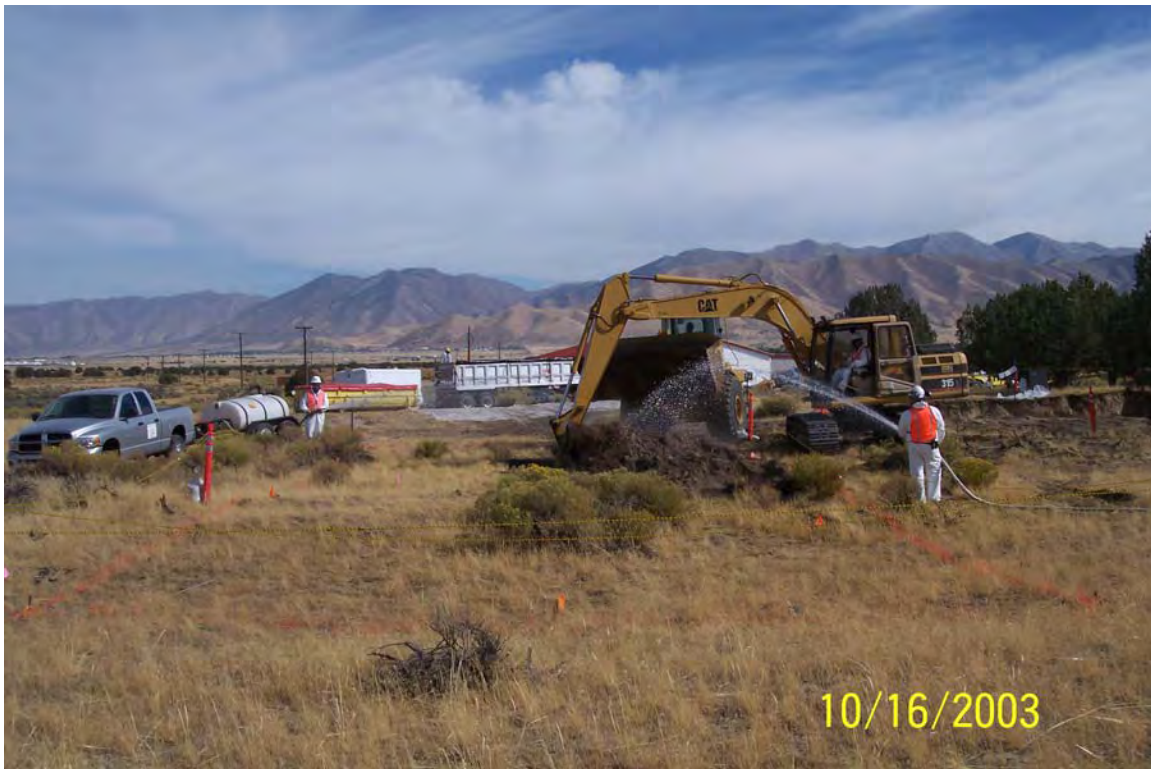
Figure C-20. Start of Waste Pile 1 excavation with dust control.

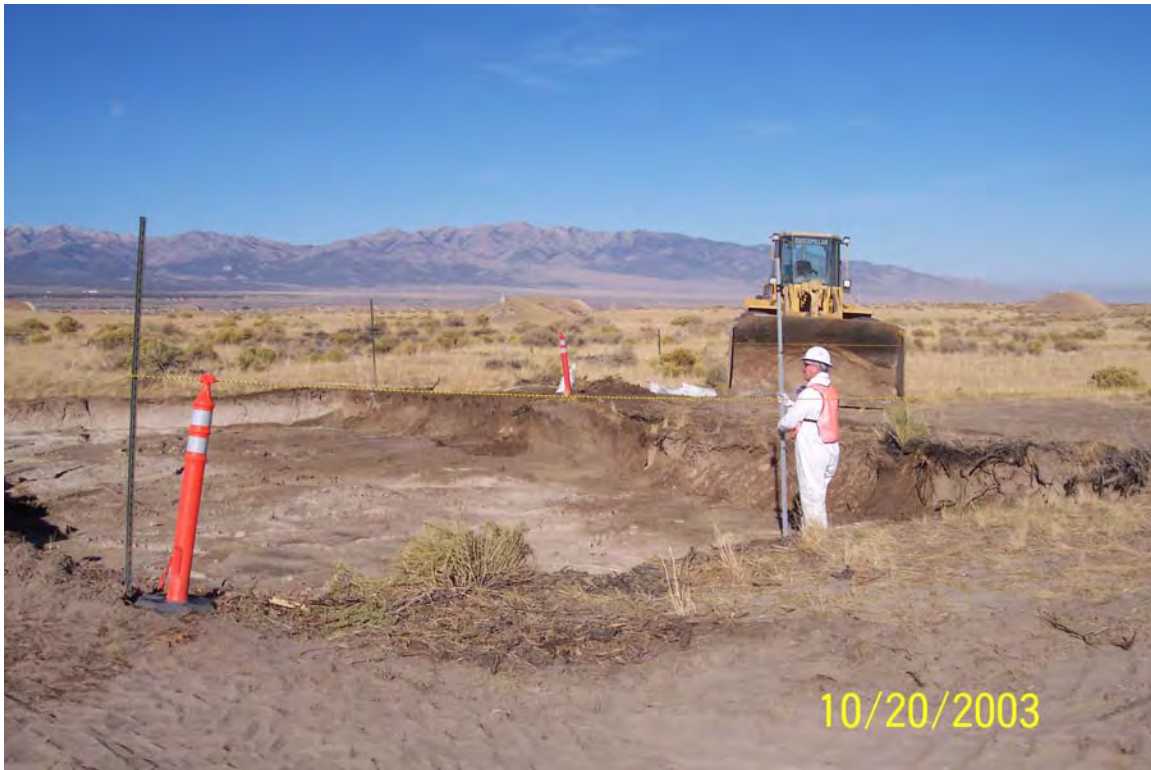
Figure C-21. Checking Waste Pile 1 excavation depth with a laser level.

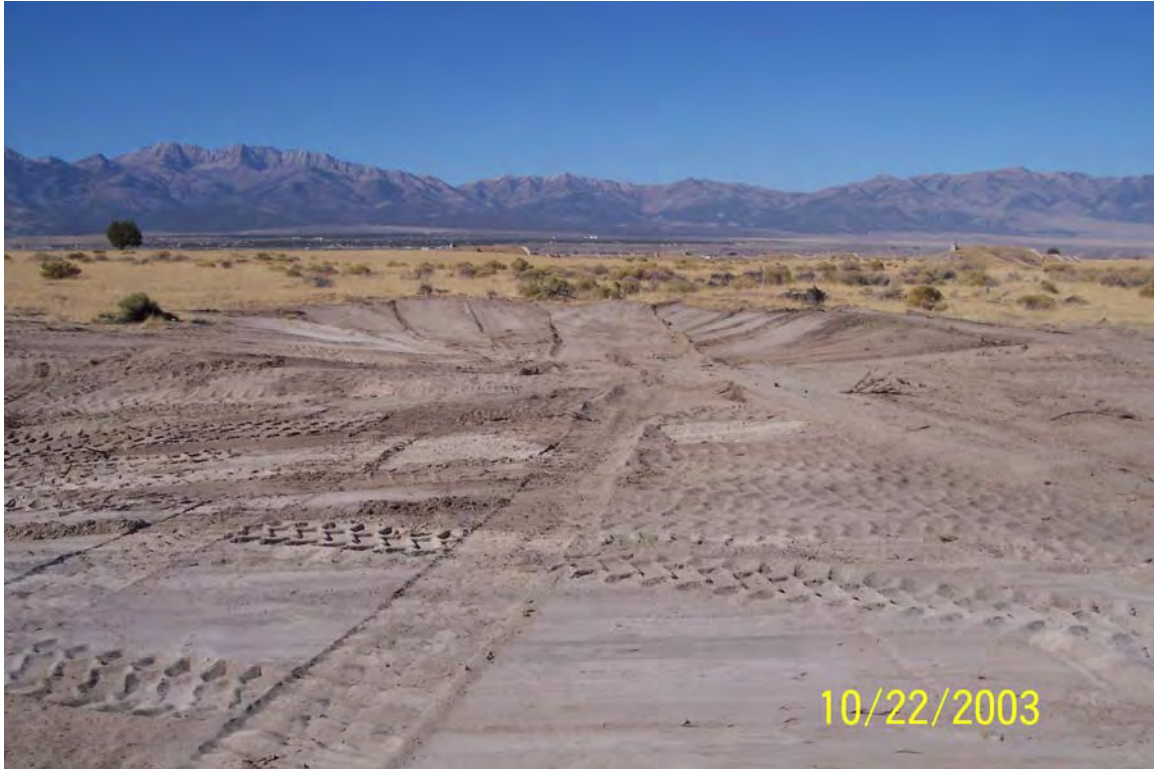
Figure C-23. Contoured Waste Pile 1.

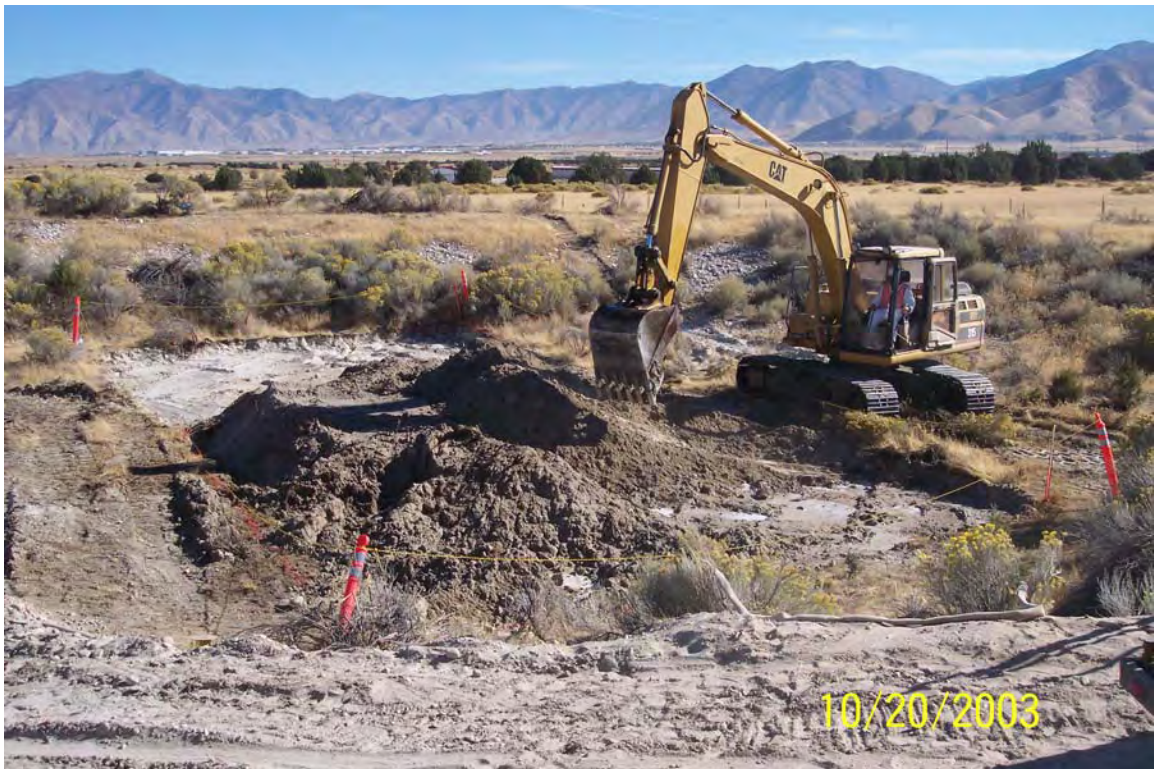
Figure C-24. Sewage pond excavation in progress.

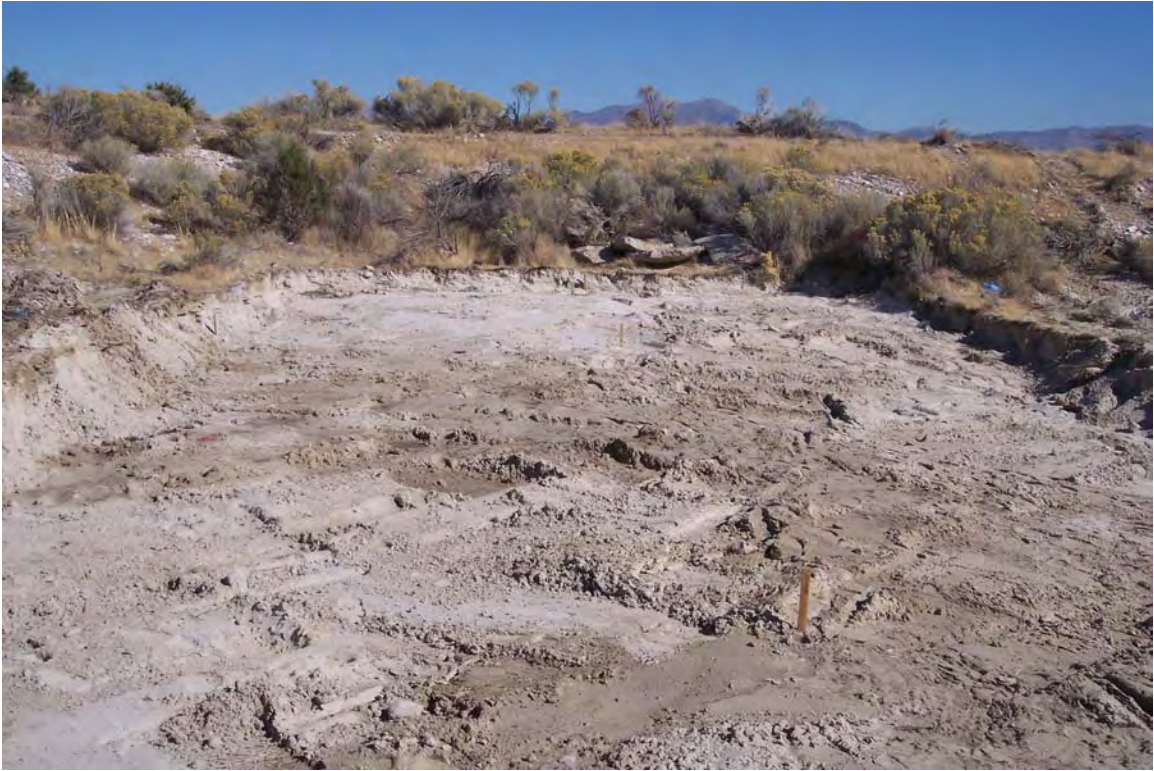
Figure C-25. Completed sewage pond excavation.

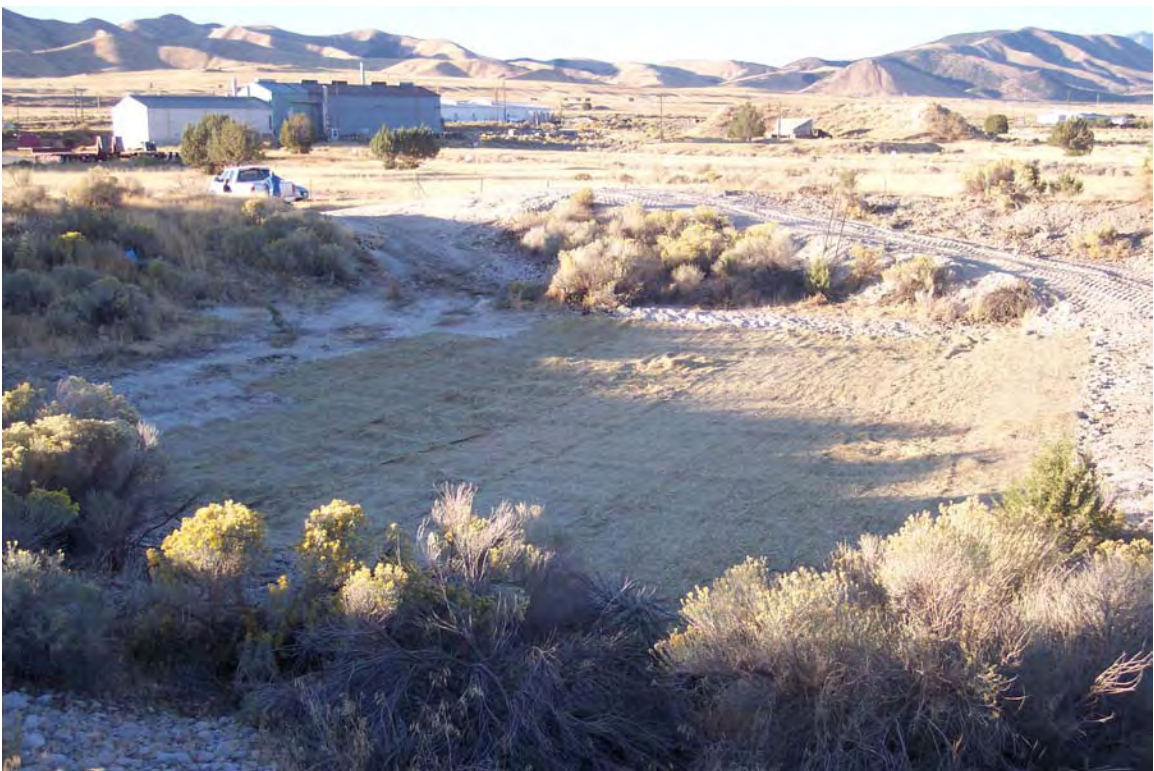
Figure C-26. Completed biomat installation in the sewage pond excavation.
